**Complaint: Wopumnes501c3
and Wanda Nagel v. PG&E**

Santa Cruz County v. PG&E C2101014
CalFire NOVs EXHIBITS 1-6

**RE: Notice of Violation #3 – CZU Lightning Fire Utility Work
 1-20NON-00122-SCR**

**RE: Notice of Violation #4 – CZU Lightning Fire Utility Work
 1-20NON-00122-SCR**

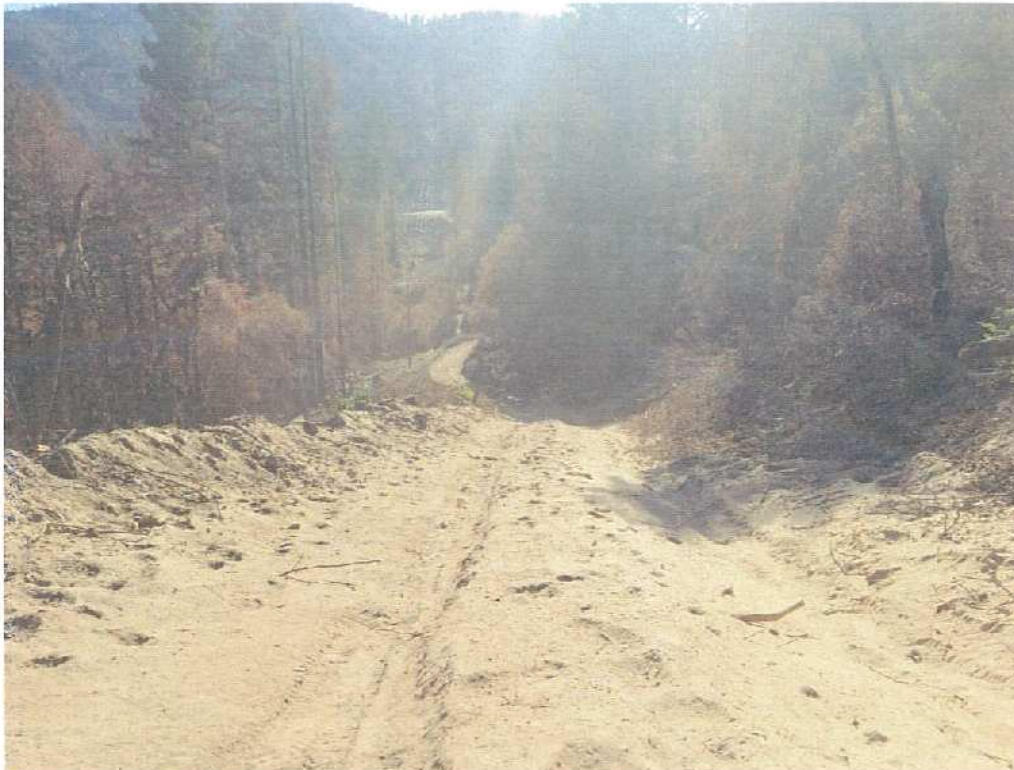
Not watering seasonal roads on your operations is a common issue that we continue to observe. We see roads watered in one section one day with frequent use by your crews and no water truck returning for several days and other roads that don't appear to ever get watered. This has resulted in the loss of integrity of the road surface and excessive buildup of dust which is a significant source of sediment during initial rainfall events. We have observed this on just about all seasonal private roads associated with this operation. This is a violation of 14 CCR §§ 923.7(c). In addition to lack of maintenance of the road surface, lack of waterbar installations or cleanout of rolling dips was observed. As this is after the start of the Winter Period, this is a violation of 14 CCR §§ 916.6(a).

Photo taken 11-4-2020 by S. Bullock Photo Point SB-2. Shows lack of road watering and waterbars on seasonal road. Note, this road segment is on Big Basin Water Co. Lands in the Boulder Creek watershed above numerous water intakes and Coho and Steelhead habitat.

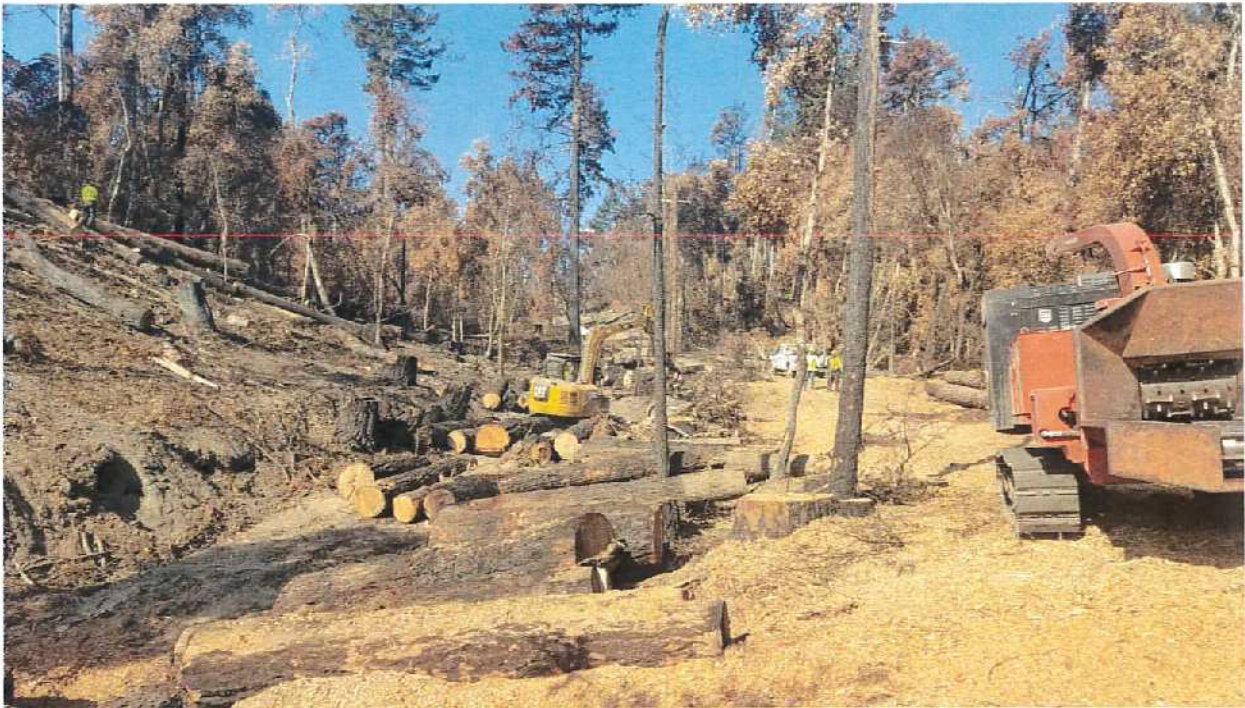
On October 30, 2020 I observed Mountain Enterprises Inc. equipment working on the westside of Swanton Road on the hill north of the Scott Creek Bridge near the old School House. The powerline parallels what appears to be a Class III watercourse for 150 yards. The current road is under the powerline and an old road bed is just west of it in a draw. Drainage has been diverted in the past into the old roadbed away from the new road and a channel has formed.

This channel meets the definition of a Class III watercourse and drains into Scott Creek 800' below. I observed evidence of runoff at this location following the slight rainfall this past weekend that transported sediment into Scott Creek which is a Class 1 stream. I observed logs deposited in the Class III channel and an excavator working directly in the channel. In discussions with the crew, they told me that they had not received any direction about dealing with the watercourse including a decision to either remove or stabilize the debris in the channel. This is a violation of both 14 CCR §§ 916.4(c)(1) and (3). It should be noted that this site is within the Coastal Zone.

Photo taken 10-30-2020 by R. Sampson. Photo point RS-2. Shows operations in a Class III drainage.

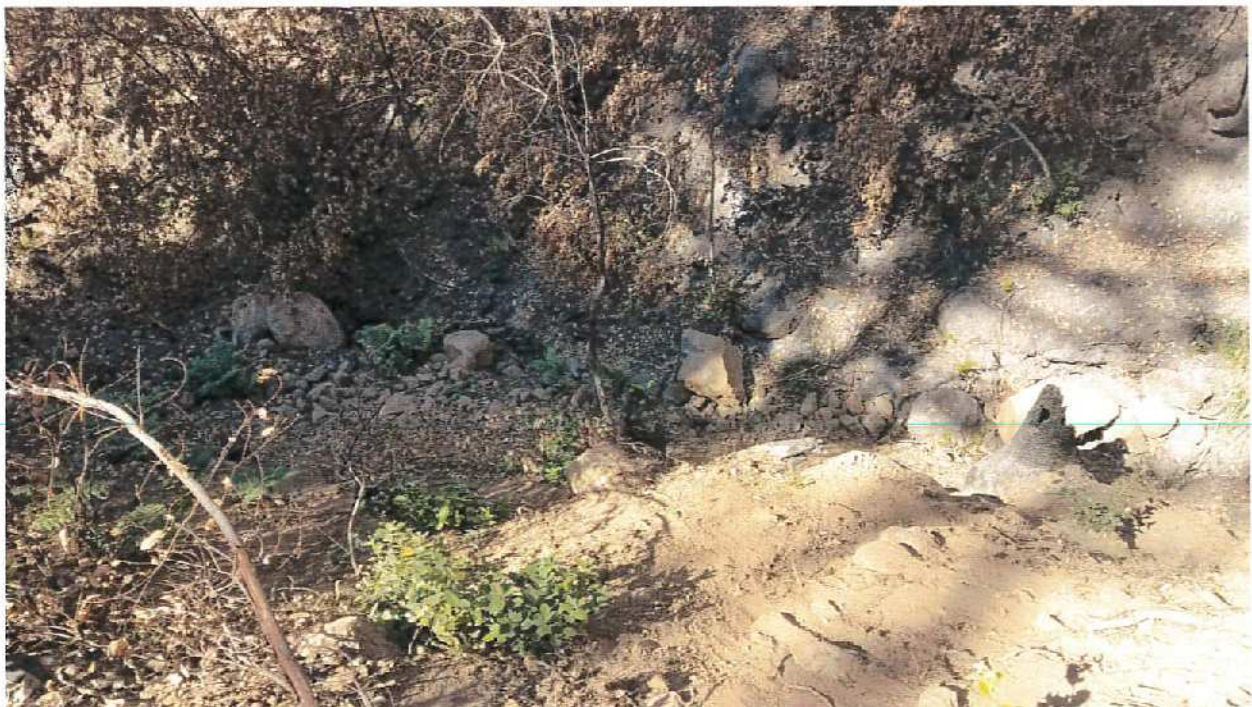
On October 30, 2020, while on the Redtree Properties LLC THP (1-18-179-SCR), I observed soil and debris deposited directly into Hyman Creek, a Class II drainage. Included in the grading project was a short (100') spur road on 50% slope leading to a new powerpole installed as part of the transmission line repair following the fire. The spur road had no waterbars or other drainage, was surfaced with loose fine soil and as graded storm runoff would drain down its entire length directly into Hyman Creek. There was no evidence of erosion control work at this site which normally would include removal of the soil from the stream channel along with straw or waterbars on the spur road. This is a violation of 14 CCR §§ 916.3(b).

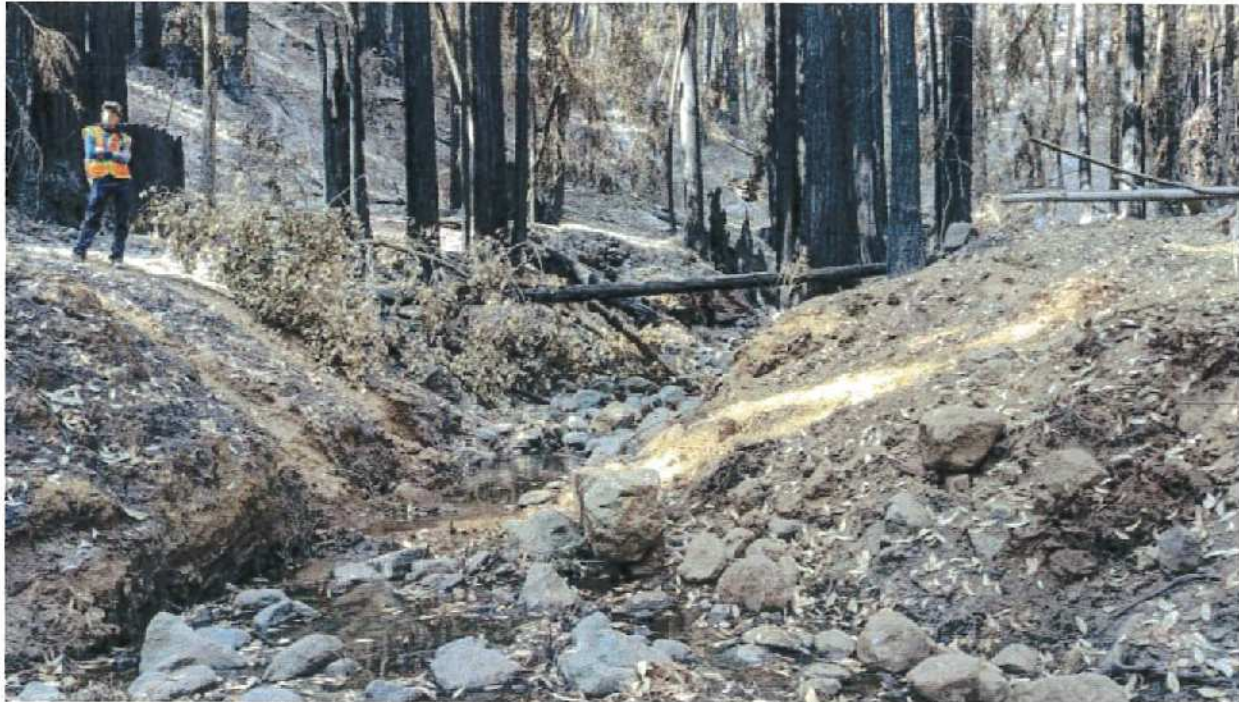
During the period where active fire was burning in the San Vicente Creek area, I received reports of a crossing of San Vicente Creek, a Class I fishery, by a large tracked vehicle, possibly a bulldozer, by a PG&E contractor working to repair the transmission line. I received a photo from the Land Owner (San Vicente Redwoods, Nadia Hamey) showing evidence of that event (See below). Hamey told me that she took that photo when meeting with PG&E representatives to discuss how they were going to mitigate the damage the utility was responsible for.

Post fire photo at Photo Point RS-4, taken by RPF Nadia Hamey. Shows track marks of equipment crossing of San Vicente Creek.

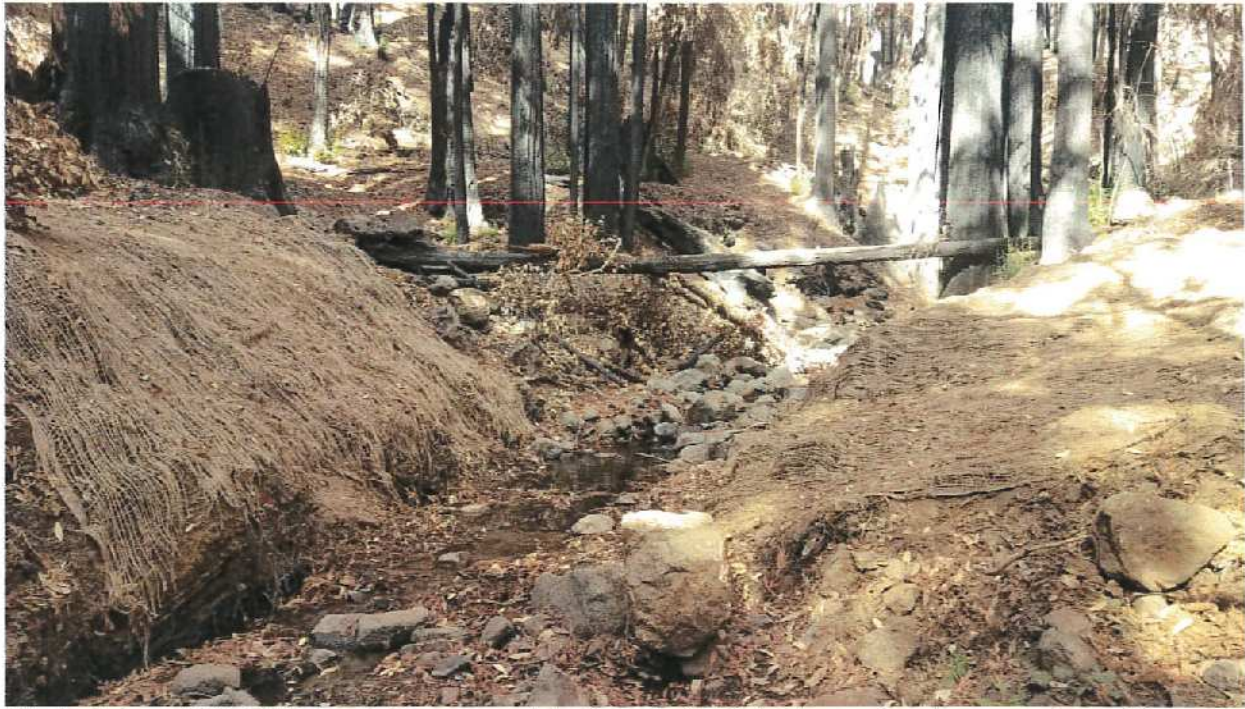
In addition, I saw evidence that the efforts to mitigate the recent damage to the watercourse were inadequate given current conditions at the site. Both approaches to this crossing are tractor roads on steep slopes with loose soil resulting from excessive use by heavy equipment without soil stabilizing measures. The amount of heavy equipment activity that occurred at this site since the fire has generated a deep layer of fine sediment that is perched upslope from this Class I watercourse.

Photo taken 11-6-2020 by R. Sampson. Photo point RS-4. Shows tractor crossing of San Vicente Creek after previous corrective work. Note extent of jute netting only 15' each approach and bare soil not covered at base of left (west) approach.

The hand dug waterbar on the west approach to the crossing is less than 4" deep and given the length and steepness of the skid trail above, that one stand alone, substandard waterbar is not adequate given conditions and events I've observed at that location during past winters. The eastern approach has deeper loose soils with poor drainage extending up the tractor trail for over 200'. I saw little to no filter capacity for the expected runoff. Standard protection measures required by the rules would require several waterbars that were at least 12" deep and straw mulch or slash packing to provide coverage from the channel out to the edge of the WLPZ boundary (100') on both sides.

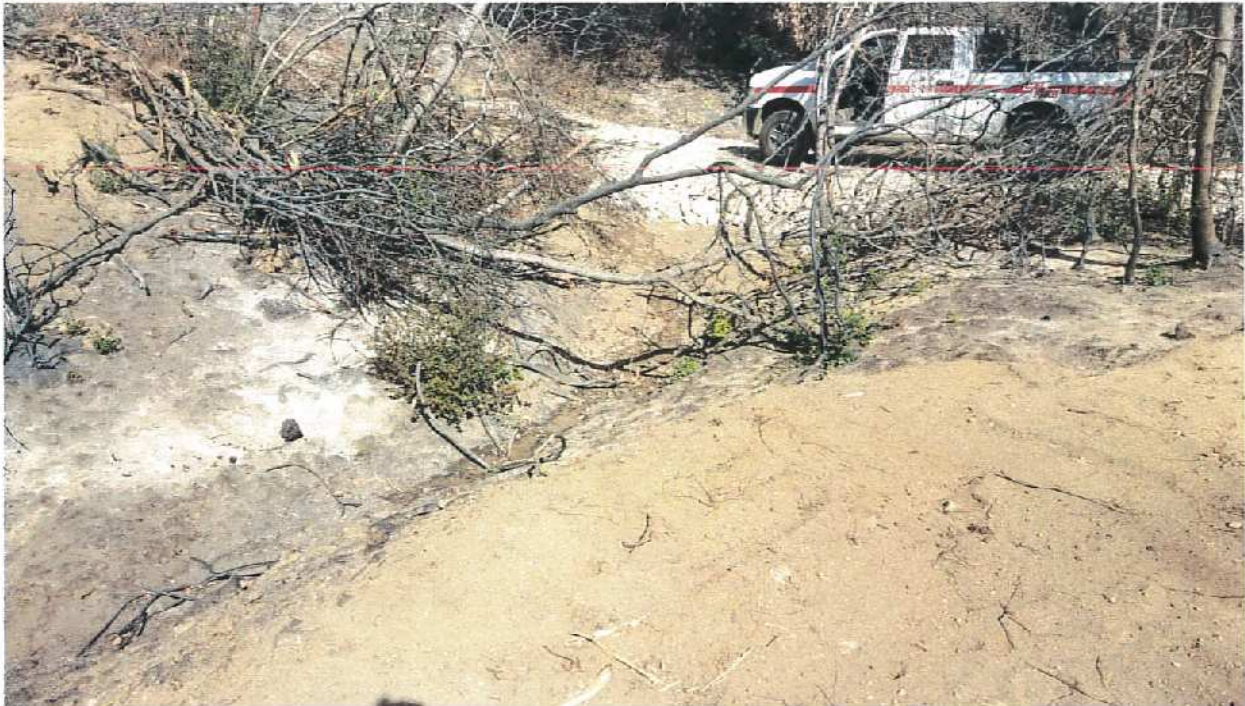
The PG&E Burns – Lonestar Transmission line parallels the west side of Empire Grade Road between its crossing of San Vicente Creek by Los Robles Road and a point where it crosses Empire Grade north of Camp Ben Lomond. Along that line the road had been regraded and numerous sections have fill perched adjacent of above watercourses. As the winter period started on October 15th, and there was more than 30% chance of rainfall on the day this was inspected (November 6, 2020) this is a violation of both 14 CCR §§ 914.6 and 916.9(n)

Photo taken 11-6-2020 by R. Sampson. Photo point RS-5 looking east upslope. Shows Class III drainage with new rocky crossing but lower right is uncontrolled bare filled created during operations. Drainage across this fill (see next photo) is all directed down its length into the watercourse channel without breaks or filter.

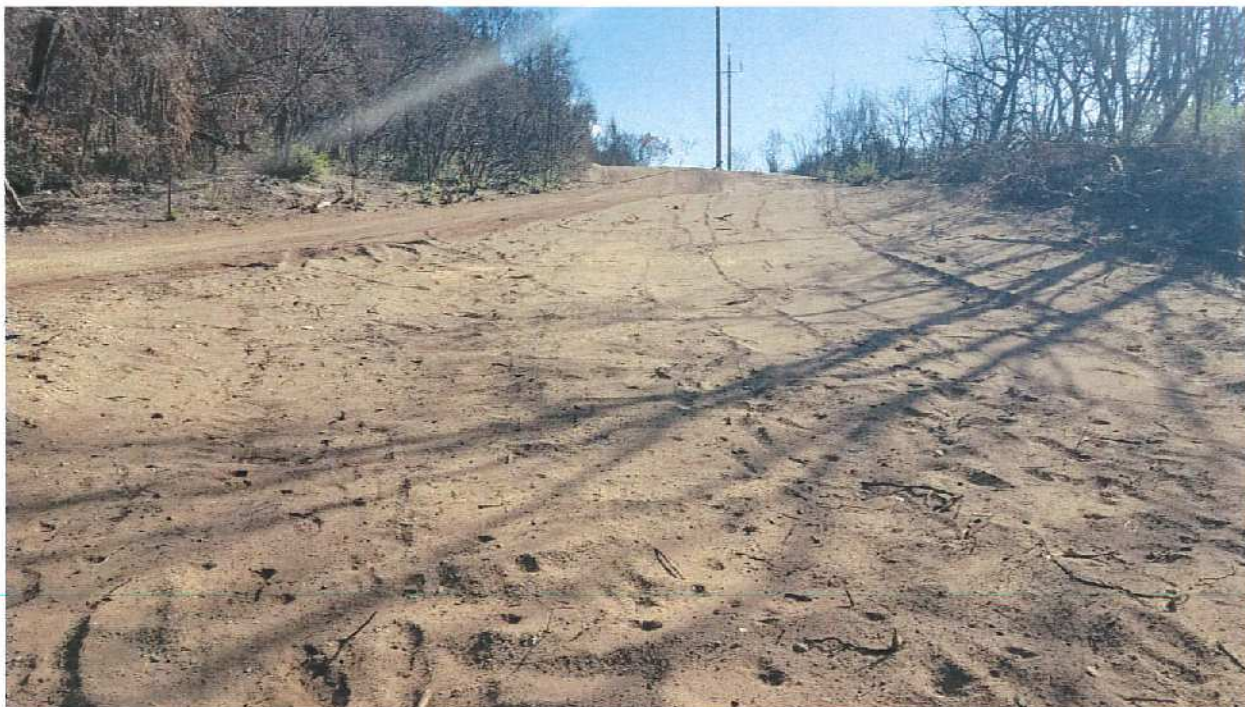
Photo taken 11-6-2020 by R. Sampson. Photo point RS-5 looking south along the ROW.

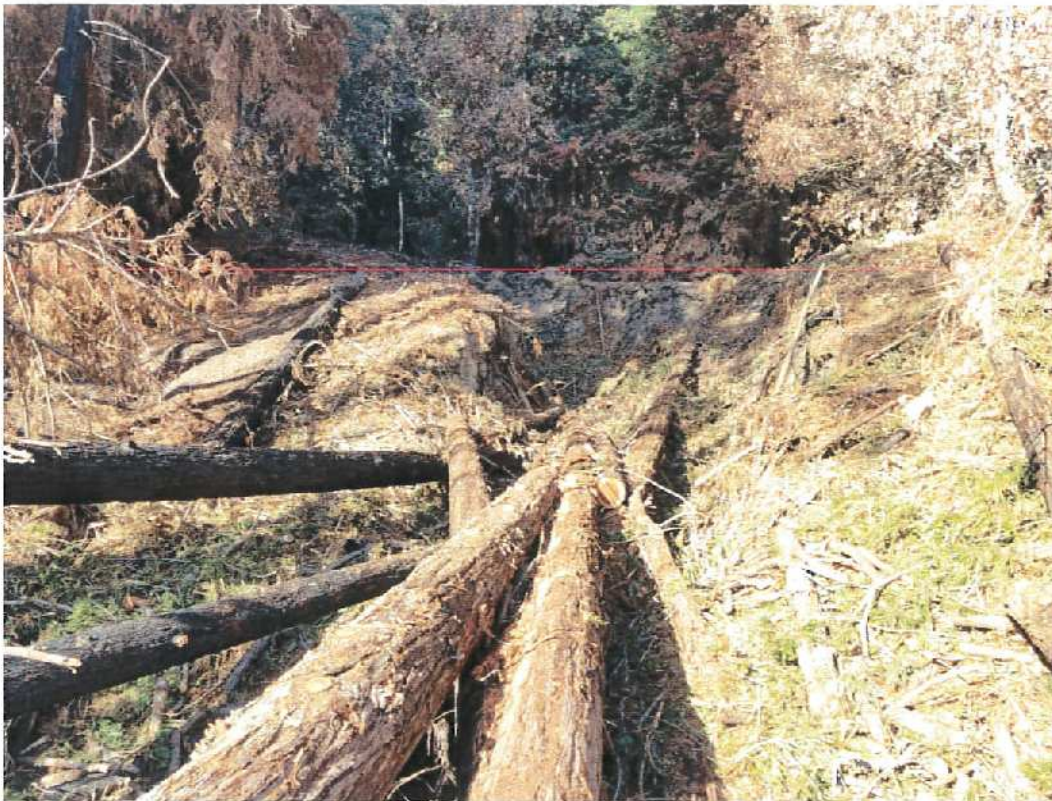
On San Vicente Redwoods property, east of gate 12, at Photo point SB-9, a known unstable area was inspected. The CAL FIRE Forester observed evidence of recently cut redwoods and equipment operations within the unstable area. This is a violation of 14 CCR §§914.2(d).

Photo taken 11-7-2020 by S. Bullock Photo Point SB-9. Shows unstable area below Gate 12 Road.

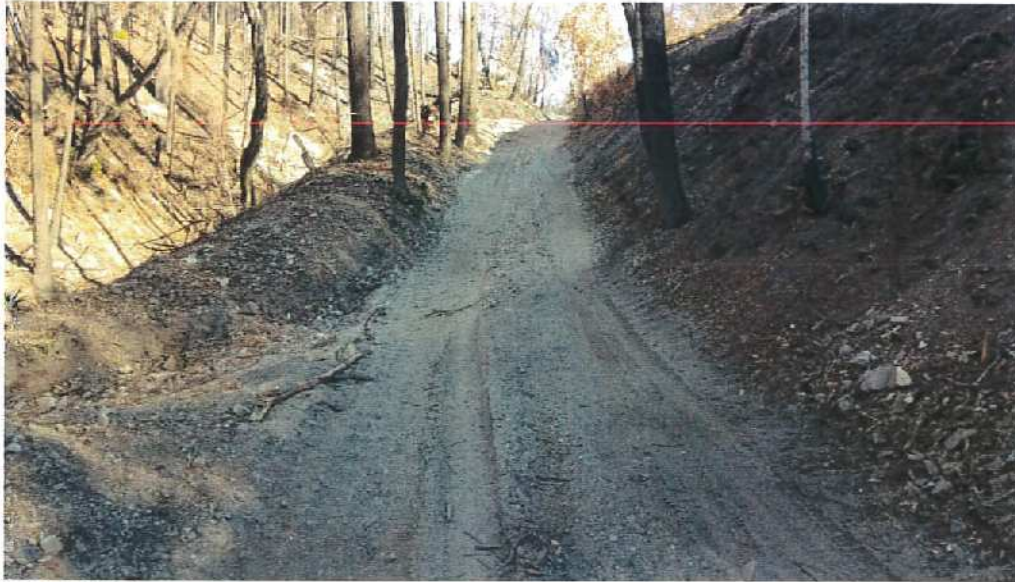
My main concern continues to focus on what I estimate to be over 17 miles of seasonal roads, utilized by your crews in their Timber Operations that have either not been maintained during those operations or have not been prepared for winter rains or a combination of the two. This is a continued violation of 14 CCR §§ 914.6(a)(1).

Photo taken 11-16-2020 by R. Sampson Photo Point RS-1. Shows seasonal road that appears to not have been maintained during Timber Operations (watered and graded) with dirt and debris blocking outlet of drainage feature. Note, previous photos taken at same location showed ungraded road with 4" deep powder surface.

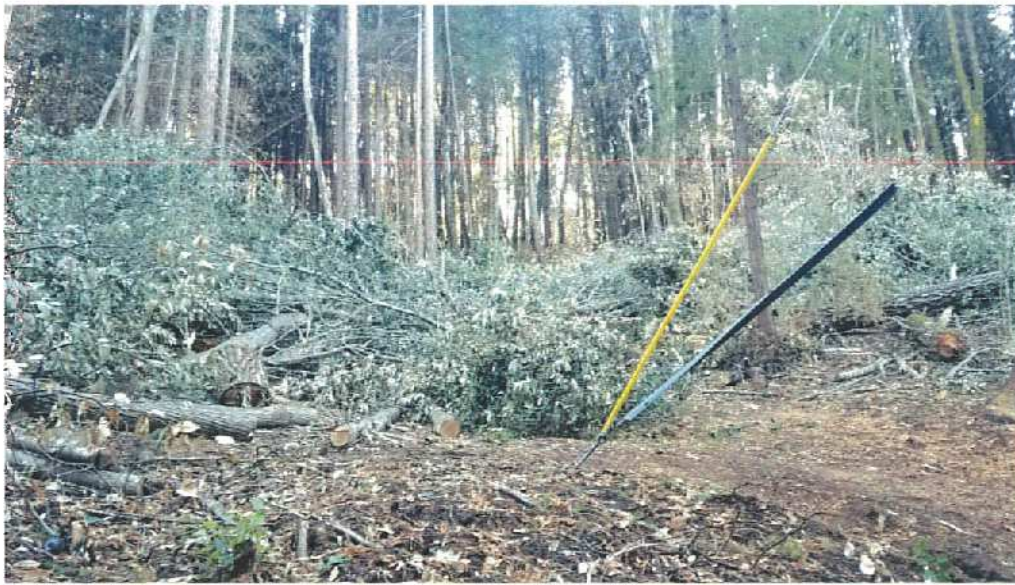
Photo taken 11-16-2020 by R. Sampson Photo Point RS-8. Shows new clearing work on Santa Cruz City Water Lands along Ice Cream Grade Road.

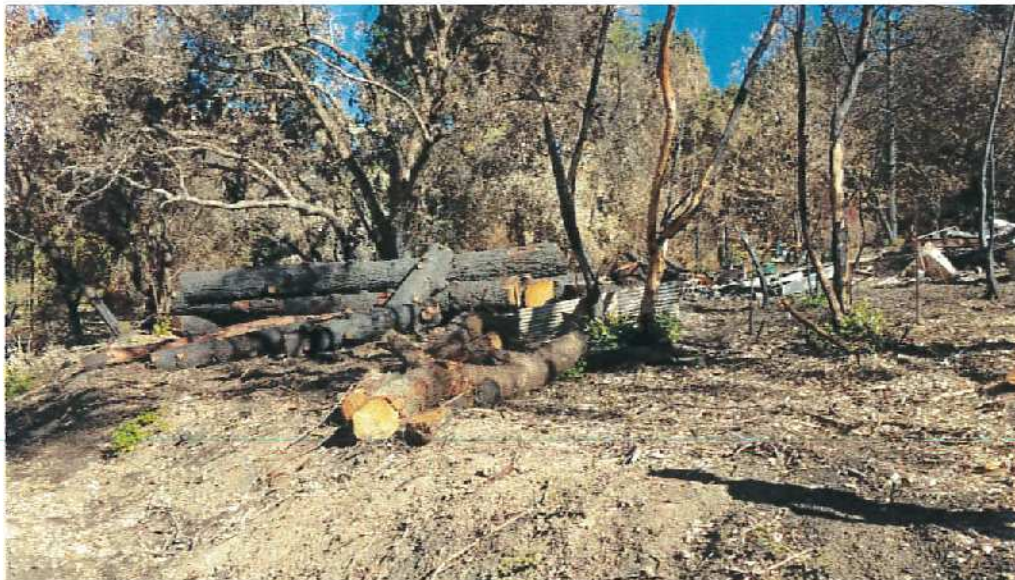
The second most common complaint I have been receiving from landowners is the amount of material and slash left on their properties following your crews. Large piles and decks of large logs in addition to large slash piles are frequently seen in these burned over neighborhoods where the utility work has been initiated. Some of this ongoing work was observed during my inspection on November 16, 2020.

Photo taken 11-16-2020 by R. Sampson Photo Point RS-6. Shows large (36" x 20") Douglas fir logs left on 100 Los Robles Dr. property.

off to any mill that would accept them. I strongly encourage the utility to work with these landowners to assist removing this debris generated by your operations.

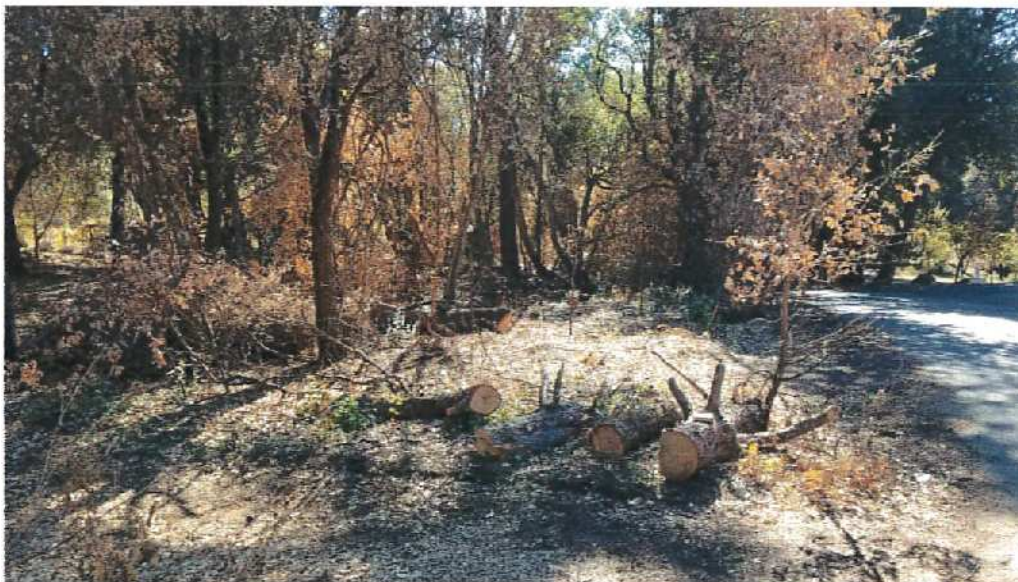
Photo taken 11-16-2020 by R. Sampson Photo Point RS-7. Shows slash and large chunks of wood left on 111 Molina Dr. property.

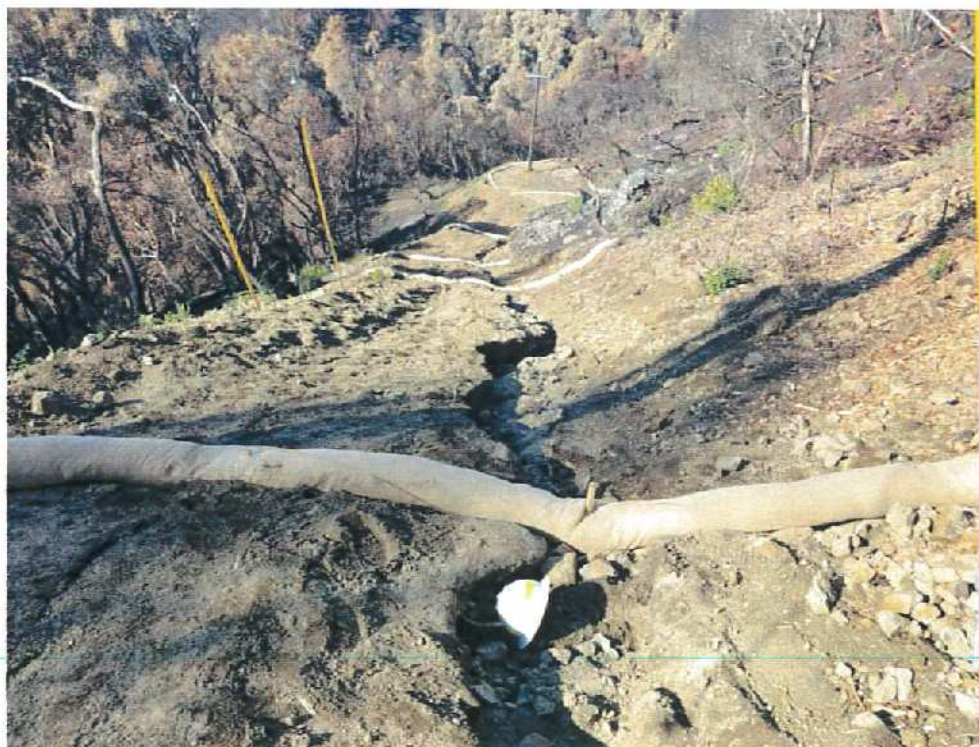
Photo taken 11-19-2020 by S. Bullock Photo Point SB-5. Note depth of new channel after one rainfall event.

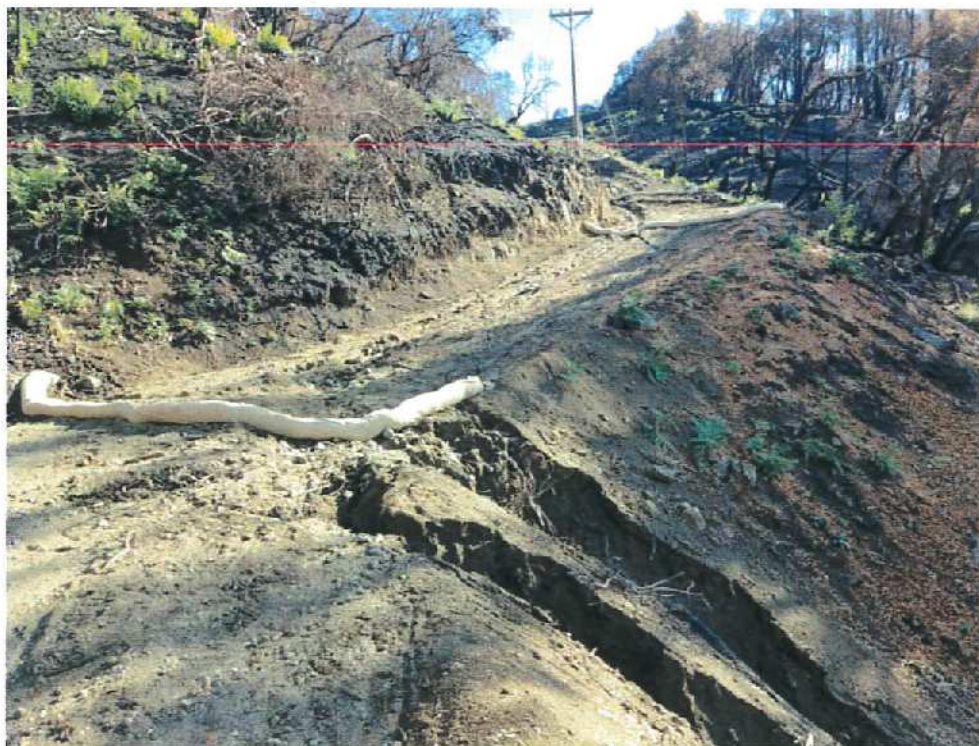
Photo taken 11-19-2020 by S. Bullock Photo Point SB-22. This is the end of the road segment from SB-5 above. Estimated 10 yards of sediment delivered directly into a Class III Watercourse.

These previous 2 locations (SB-22 and SB-23) where sediment has entered a watercourse generated from a seasonal road that lacked adequate erosion control work shows that the roads are not hydrologically disconnected from the watercourse. These are both violations of 14 CCR §§ 923.5.

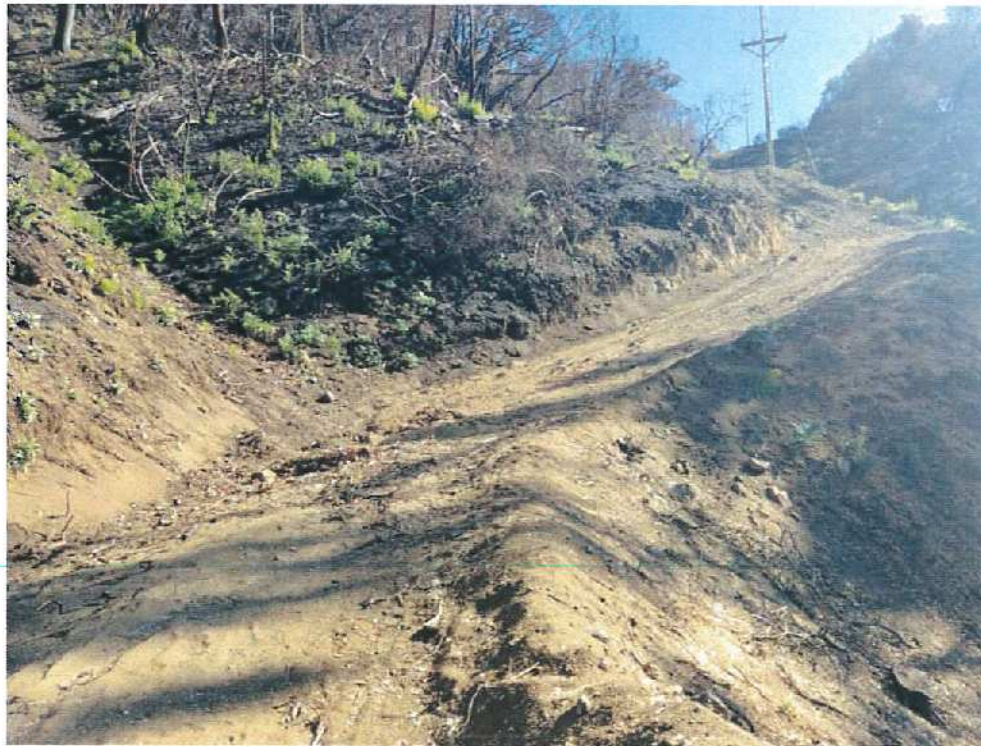
Photo taken 11-14-2020 by S. Bullock Photo Point SB-22. Shows same view as previous photo but prior to 3" rainfall event. Note lack of any drainage and outside berm on road.

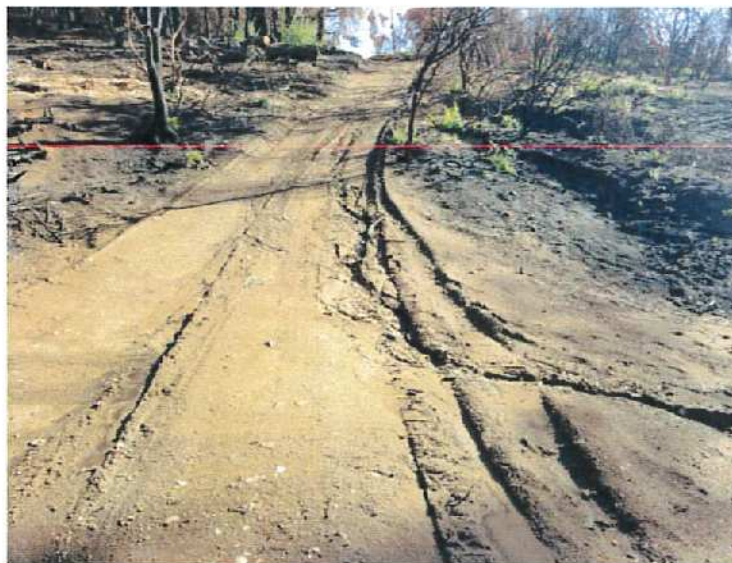
Photo taken 11-19-2020 by S. Bullock Photo Point SB-23. Shows seasonal road after 3" of rain with rilling and displaced sediment flowing into a Class 3 watercourse without erosion control efforts.

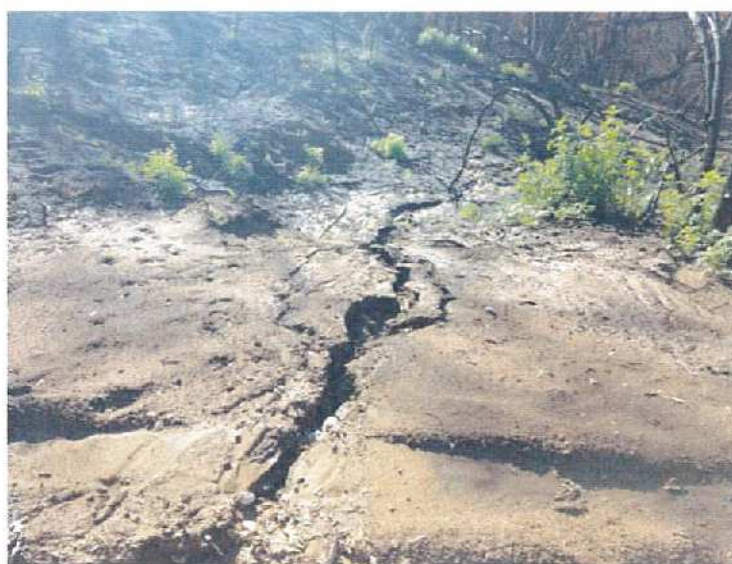
Photo taken 11-19-2020 by S. Bullock Photo Point SB-23. Shows same location but looking downstream from crossing down the Class III watercourse. Estimate 3 yards of sediment transported into channel.
